## **CITY OF SUBIACO COUNCIL RESOLUTION – NUMBER OF SIGNIFICANT TREES**

**ANNEXURE 3 – REPORT BY CLASSIC TREE SERVICES**

## ARBORICULTURAL SITE INSPECTION ASSESSMENT

### SUBIACO OVAL DEMOLITION FINAL REPORT

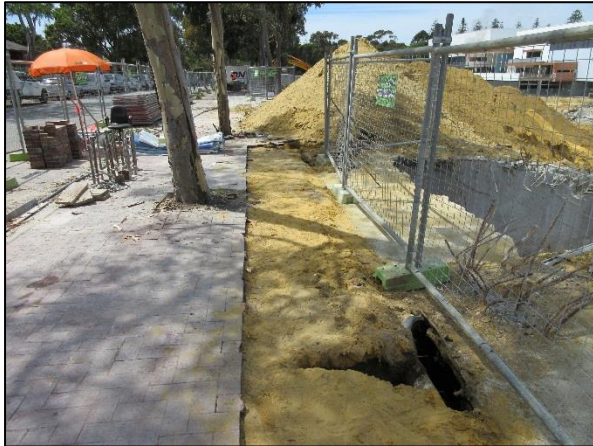
**3.1** Between the 2<sup>nd</sup>, 8<sup>th</sup> and 14<sup>th</sup> of October 2019 the removal of the footing of the northern grandstand was undertaken and supervised. This excavation work was well within the TPZ of all the trees along the Subiaco Rd frontage. Prior to the works commencing, exploratory vacuum excavation was carried out to determine the extent of root development next to the footing. The findings were surprising with only absorptive roots found and no structural roots. This evidence suggests a deeper, more vertical structural root system so the footing removal was approved. The demolition of this section of the wall was carried out under arborist supervision with the use of a large excavator working from the south of the trees. The wall footing was slowly pulled away from the trees, any exposed roots noted, clean fill placed back in place of the wall and slightly compacted with the use of a front end loader. The quick replacement of the fill soil ensured any exposed roots were covered to avoid drying out and the edaphic nature of the remaining soil is maintained. General arboricultural knowledge which is taught and learnt typically states tree root systems spread out laterally throughout the soil profile, with the majority of roots found

**Image 1 – Exploratory vacuum excavation**

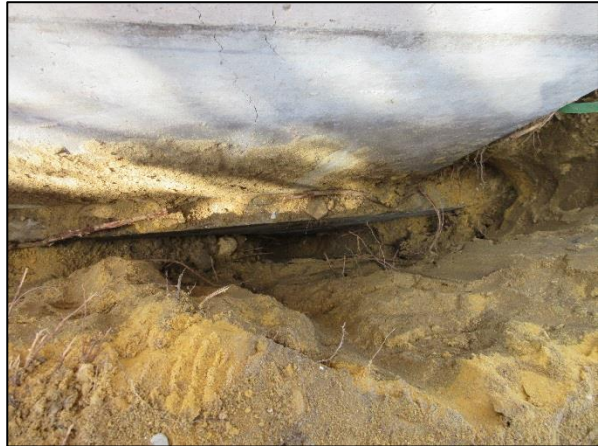
within the top 900mm. In this instance and throughout the site we have found evidence contrary to this statement which can be attributed to the species of tree, its direct environment within hardstand infrastructure and the sandy soils present. Based on these findings and methods used it is not likely these trees will be compromised structurally but there is expected to be some vitality loss, with future environmental conditions playing a large role in this outcome therefore additional watering and nutrient application will be recommended.

**Image 2 – Absorptive roots within excavation**

- 4.1** Carry out nutrient application throughout site along with a soil wetting agent diluted into approximately 200L per tree. Apply this at 3 monthly intervals for the next 12 months.
- 4.2** An installation of Medicap™ tree nutrients should be carried out on the *Corymbia ficifolia* on the Roberts Rd side of the development to boost tree health. These trees have been in declining health since before the start of demolition works and now, they have survived will need some additional care if they are to be retained.
- 4.3** An inspection of the site in January 2021 is recommended to pick up on any tree health decline or water deficiencies as the warmer weather will exacerbate any underlying issues.

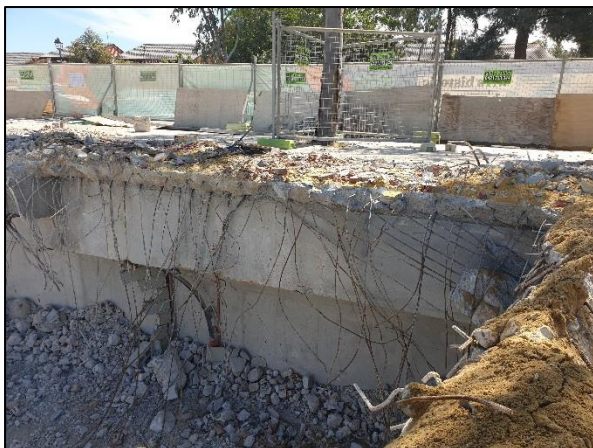
**Image 3 – Footing adjacent *C. maculata***

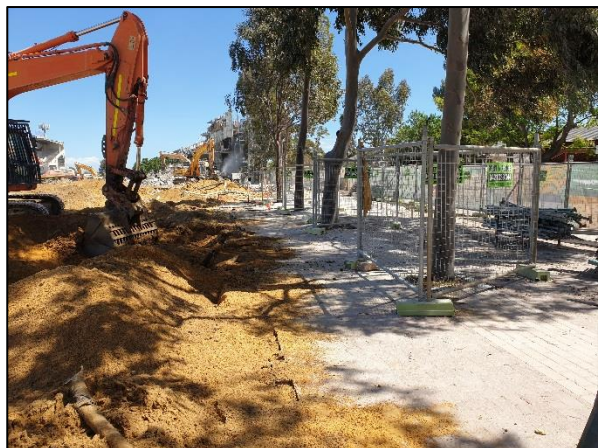
**Image 4 – Soil replaced after footing removal**

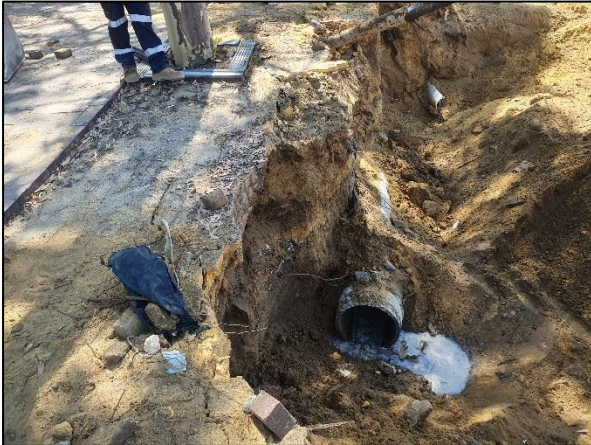
**3.3** The Subiaco Rd side of the demolition also required the removal of an existing storm water pipe. This was located just behind the footing wall in between the wall and the *C. maculata* towards the east of the project. Again, vacuum excavation was carried out to ascertain the development of roots within the area and after confirmation of no significant roots within the area, the work was approved. This was carried out with the same method used previously on 10<sup>th</sup> December 2019 with sections excavated, pipework removed and backfilled promptly. As a result, no structural issues were identified with regards to these trees and all roots found during the works were retained.

**Image 5 – Storm water pipe removal**

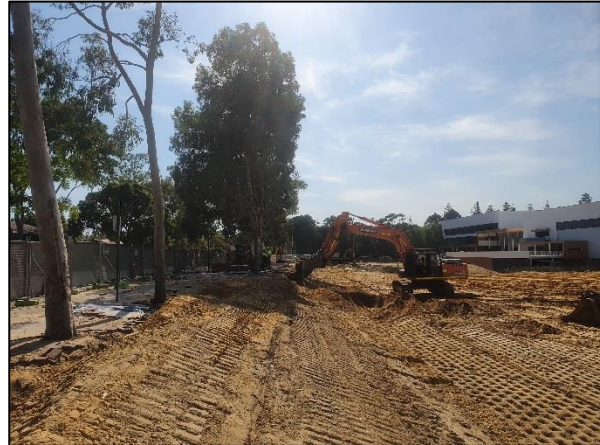
**Image 6 – Battering of fill soil post excavation**

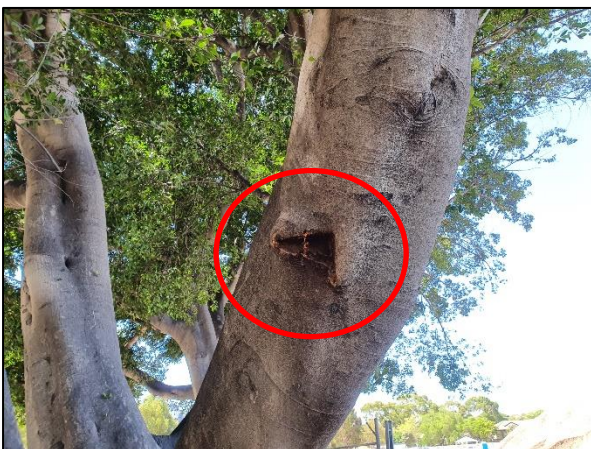
**3.4** The three large *Ficus hillii* and *Casuarina cunninghamiana* within the redevelopment footprint and on the western side of the development also needed extensive excavation within their TPZ's along with arboricultural work within the canopy of one of the *F. hillii*. This began with the removal of an old sea container from the base of the middle tree. The tree had grown around the sea container and concerns were outlined as to the structural stability of this limb once the container was removed. The limb was braced using an eight-tonne dynamic cable to ensure the limb could not fail if it were compromised and the container was removed. The damage to the limb was better than anticipated and the limb was retained with the cable bracing in situ.

**Image 5 – Wound from container**

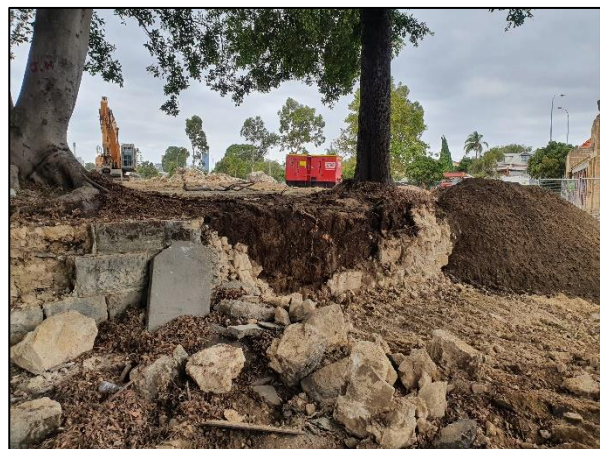
**Image 6 – Limestone wall removal**

**3.4 Cont.** The Limestone wall on the western side of the trees needed to be removed and was done so under arborist supervision on 22<sup>nd</sup> January 2020. The wall was broken up manually and with a mini excavator but where the limestone blocks were too close or too hard to remove, they were left in place so to not damage the tree roots or render the trees unstable. The completed sections were then immediately backfilled and slightly compacted to ensure exposed roots did not dry out or retain further damage and the soil maintained its structure, with evidence of this process contained within Image 6.

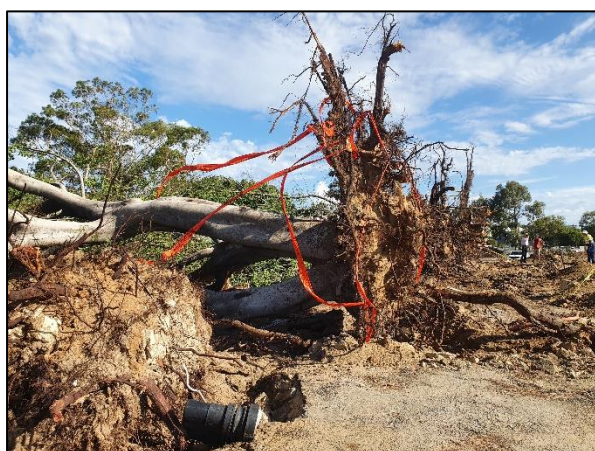
**3.5** On the 25<sup>th</sup> February 2020 a strong, unexpected and localised storm passed through the suburbs of Belmont, Rivervale, Leederville, Dianella and Subiaco to name a few. This storm cell uprooted many trees and caused many others serious canopy damage over a wide area. At this site, around the Subiaco Oval development, no less than ten trees were uprooted with many more seriously damaged with all trees pushed over from a North-Easterly direction. Unfortunately, the three large Ficus trees and the Casuarina next to the limestone wall which was removed were all uprooted and damaged beyond retention. All four trees failed at the root plate with no evidence of prior root damage as the significant structural roots were either pulled from the ground or snapped off. The soil under these trees and within their respective TPZ's had not been disturbed and the only work which had been carried out within this area was the asphalt removal from the surface. With the evidence of previous work and supervision of work within trees TPZ's, the failure of the trees at this site were all due to the extreme weather event and root damage or excavation work could not have possibly been the cause of failure.

**Image 7 – *Ficus* and *Casuarina* failures**

**3.6** The week following the storm, RJV initiated a contractor to attend site to remove the fallen trees and carry out remedial canopy pruning to the trees which sustained damage during the storm. The site arborist outlined the work which needed to be carried out and walked through the site with the Cert III qualified arborists from Thomas Contracting. The work consisted of hanging branch removal, failed limb removal and cleaning up of failure stubs and wounds. All work was carried out to a high pruning standard.

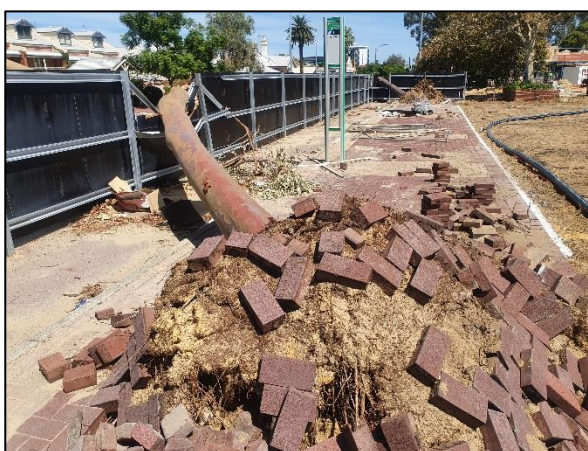
**Image 8 – *C. maculate* failure on Roberts Rd**

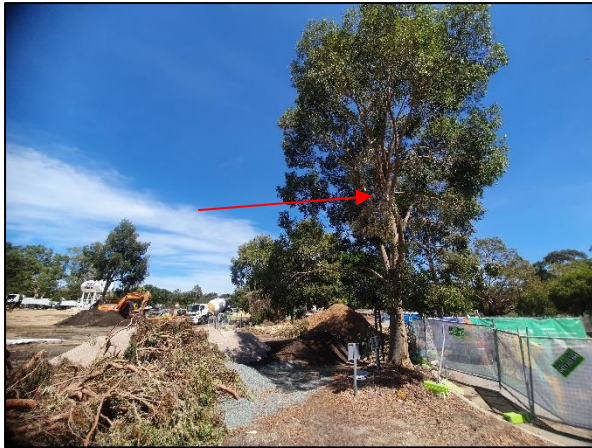
**Image 9 – Hanging branch that was removed**

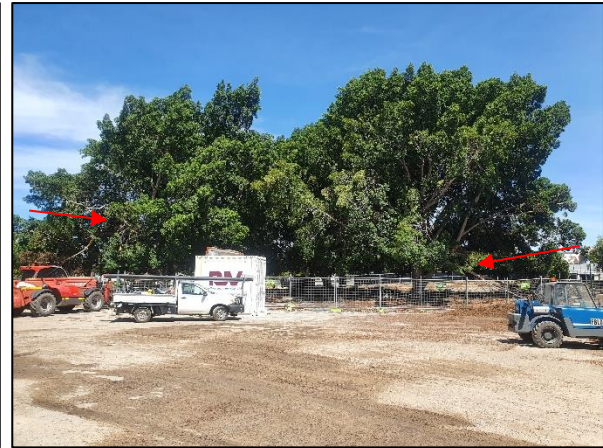
**Image 10 – Remedial work carried out**
